Manhole Inspection Summary

Manhole # S21C__030MH

Insp Date: **9/19/07 10:17 AM**

Location Address: **343 BRUCE-MOUNT**

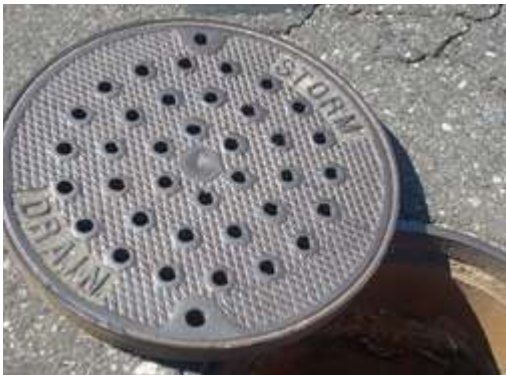
STORM DRAIN LID

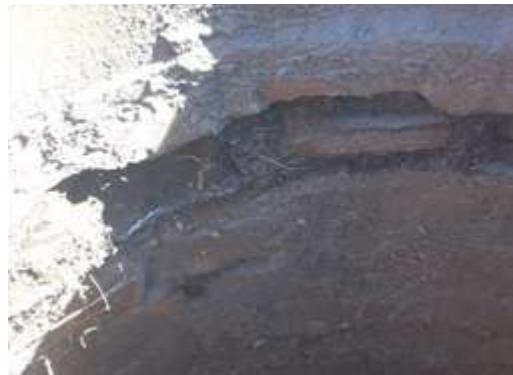
Defect 2

Condition: ☐ Sound ☐ Cracked ☐ Root Intrusion ☐ Loose Brick ☒ **Deteriorated**

CHIMNEY DETERIORATION

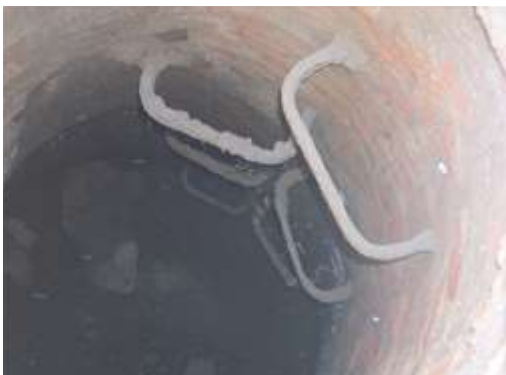
Defect 1

Infiltration: ☐ None ☐ Joint ☐ Cracks ☐ Mortar ☐ Roots ☒ **Wall**

Steps Count: **5** Missing: **0** ☒ **Corroded**

CORRODED STEPS and infiltration barrel

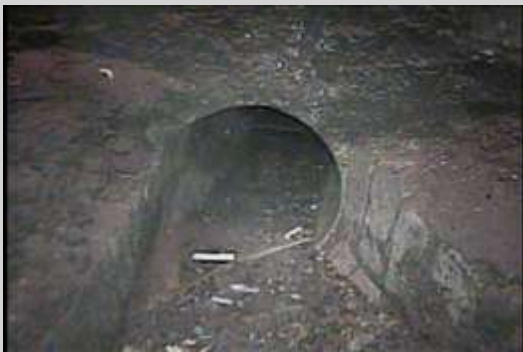
12 O'Clock Outflow

8 in. Circular Gravity Sewer
Pipe Out @ 12 O'Clock

Pipe Height: **8.4** (in.) Rod and Bar (Angled)
Pipe Material: **Clay** ☐ Pipe Lined
Invert Depth: **10.14** (ft.) Flow Characteristics: **None**
Deposits: ☐ None ☐ Mud ☐ Sludge ☒ **Debris** ☐ Grease
Silt Depth: **1** (in.) Deposits Extent: **Light**
Infiltration: **None** Pipe Seal Cond: **Sound**

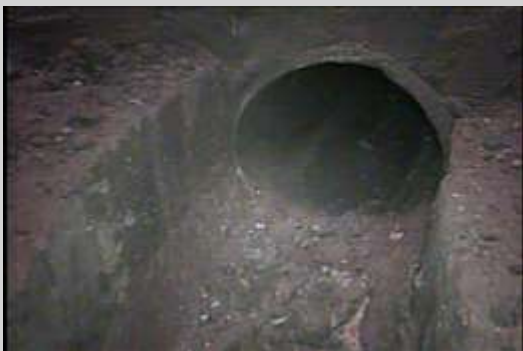
3 O'Clock Inflow

8 in. Circular Gravity Sewer
Pipe In @ 3 O'Clock

Pipe Height: **7.2** (in.) Rod and Bar (Angled)
Pipe Material: **Clay** ☐ Pipe Lined
Invert Depth: **10.02** (ft.) Flow Characteristics: **None**
Deposits: ☐ None ☐ Mud ☐ Sludge ☒ **Debris** ☐ Grease
Silt Depth: **8** (in.) Deposits Extent: **Heavy**
Infiltration: **None** Pipe Seal Cond: **Sound**
